**DOT/FAA/AR-95/49**

# **A Study of the Continued Fire Worthiness of Aircraft Seat Cushion Fire-Blocking Layers**

March 1997

Final Report

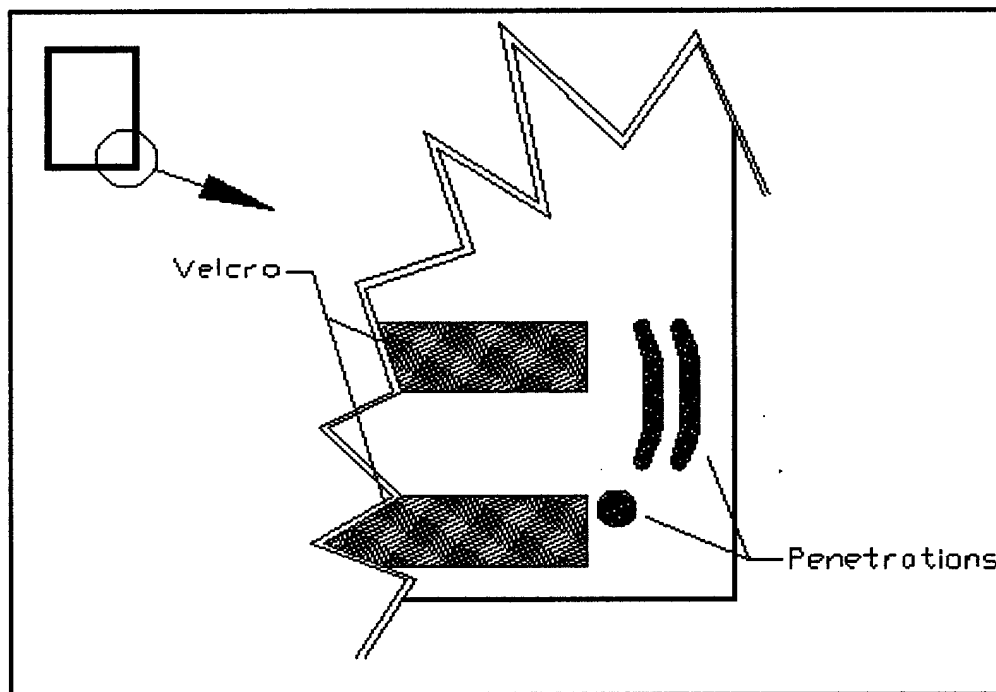
FIGURE 3. TEST NUMBER FIVE FIRE-BLOCKING LAYER PENETRATIONS  
(vertical cushion, cutaway view of rear facing corner closest to burner cone)

Test number five resulted in a weight loss of 27.47 percent. Excessive damage resulted from penetrations in the vertical cushion FBL. The three penetrations were located on the back side bottom corner closest to the burner (see figure 3). They consisted of two, four-inch by one-half-inch (10.2-cm by 1.27-cm) vertical, parallel slashes with a separation of one inch (2.54-cm); and a one-inch (2.54-cm) -diameter hole located approximately two inches (5.08 cm) below and one inch (2.54 cm) to the side, opposing the burner, from the vertical slashes. During the portion of the test when the oil burner was turned off, burning originated from the backside of the cushion. This behavior was solely due to the FBL penetrations.

Test number five demonstrated the effect of FBL penetrations. The two, four-inch by one-half-inch (10.2-cm by 1.27-cm) slashes plus the one-inch (2.54 cm) -diameter circle, provide a total penetration area of 4.78 square inches (30.8 square centimeters). Several other cushions also had penetrations in differing spatial orientations which negated propagational behavior as seen in test number five. These penetrations, found in cushions tests 9, 11, and 33, were characterized as one-inch (2.54-cm) or less diameter holes being mechanically created by vibration and friction

from contacting rivet heads or other such features in the stock seat frame. The orientation of the burner flame to the penetration played the obvious factor regarding fire development.

Penetrations to the FBL must be considered very carefully beyond the scope of a standardized test. During this work, some threshold phenomena is evident when considering the successful or failed combustion of a seat cushion. The penetration orientation with respect to a flame, the surface area of the penetration, the seat cushion material(s) and construction, and the dynamics of the flame exposure impact this threshold behavior. In the case of test number five, the penetrations were not subject to direct flame contact. However, the size of the penetrations allowed acceptable ventilation inside the fire-blocking layer resulting in combustion of the foam cushion. The danger of penetrations is demonstrated by test number five. Yet, tests 9, 11, and 33 demonstrated smaller insignificant penetrations.

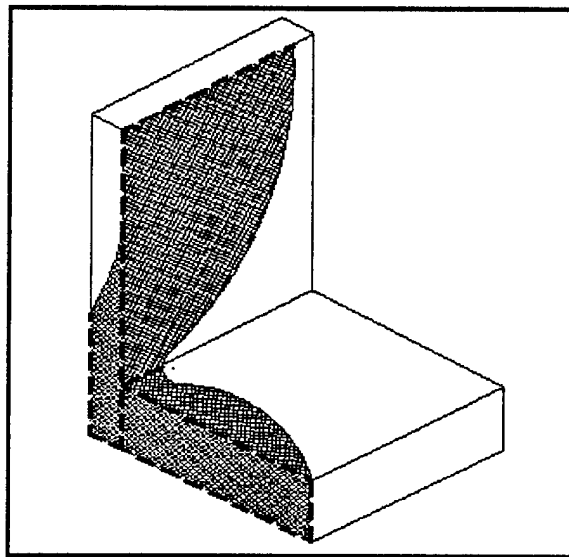
FIGURE 16. TYPICAL BURN PATTERN RESULTING FROM SEAT TEST  
(typically damaged areas are cross-hatched)

The seat cushion tests, for the most part, followed a generic sequence of events. Upon flame impingement, the vertical edge of the horizontal cushion facing the burner lost its dress cover due to combustion. The flame also contacted the upper and lower horizontal cushion surfaces of the horizontal cushion near the burner cone. The burner flame also tracked in an upward arc across the front, vertical face of the vertical cushion. The arc started from the intersection of the horizontal and vertical cushions, close to the burner, and swept upward further away from the flame source. A typical burn pattern is shown in figure 16.

The dress cover material was consumed in these areas as well. The fire-blocking materials subjected to the oil burner flame were only affected in the flame contact zone and the immediate vicinity of the burner jet. The FBLs underwent a thermal degradation which resulted in a black, charred, brittle state. In many instances, a crack formed on the vertical cushion edge which received the direct flame contact. This crack had no further negative effect in the combustion of the cushion. Excluding the vertical edge facing the burner cone, the mechanical integrity of the FBL materials were never compromised due to flame impingement.
